**Near Miss Investigation
Accident Prevention Analysis Program**

65th Street Incident

June 5, 2008

Sacramento Metropolitan Fire District

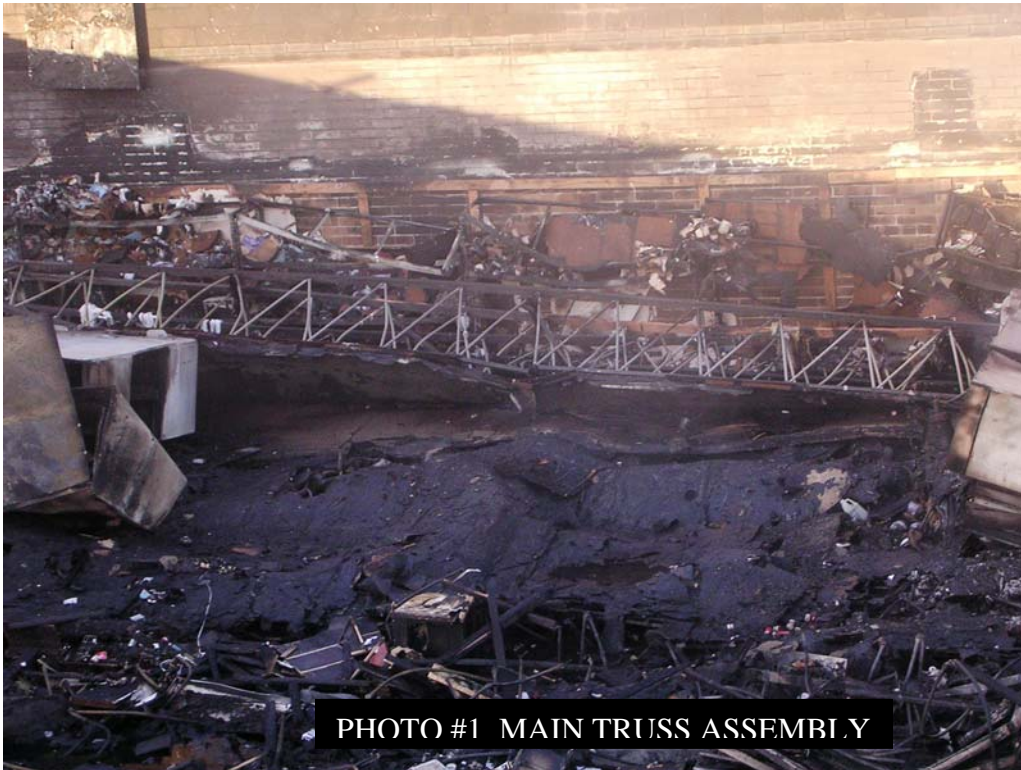
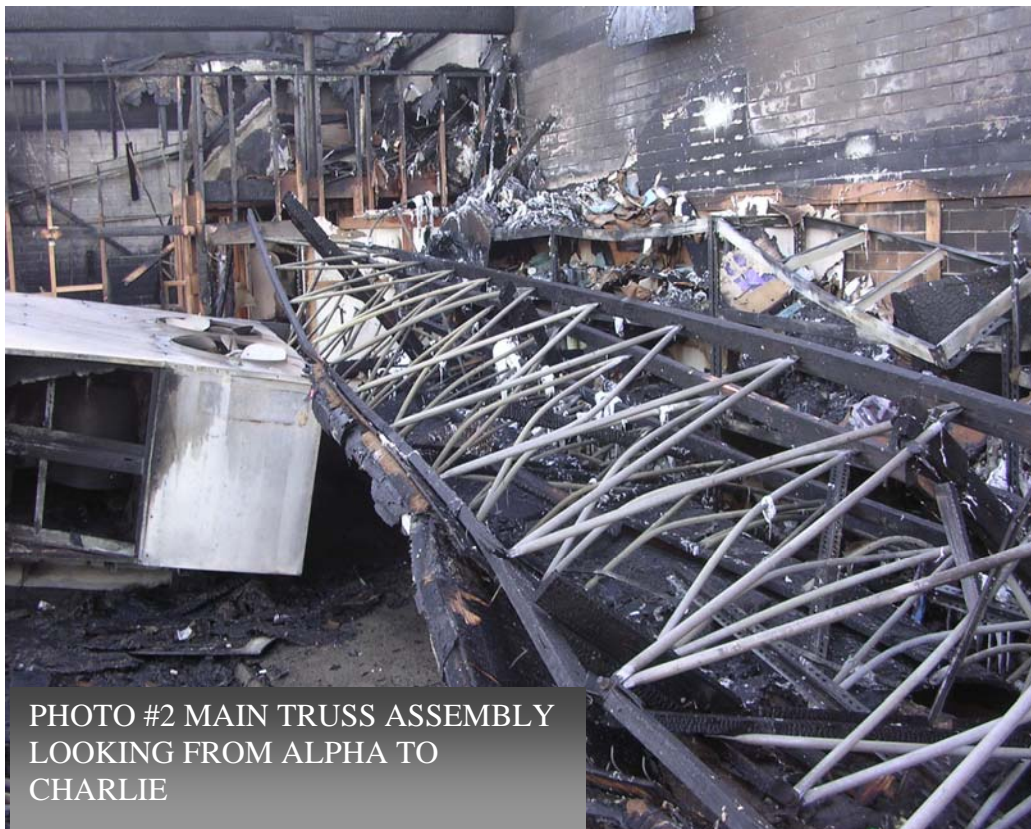
wooden top cord, a 2x4 wooden bottom cord, and 1 inch tubular steel members provided the structural support. The trusses were spaced 2-feet on center and were covered by ½ inch plywood with composition roll roofing on top. These trusses are often referred to as TJL, JLX, and TJW trusses. (See Photo #1, #2)

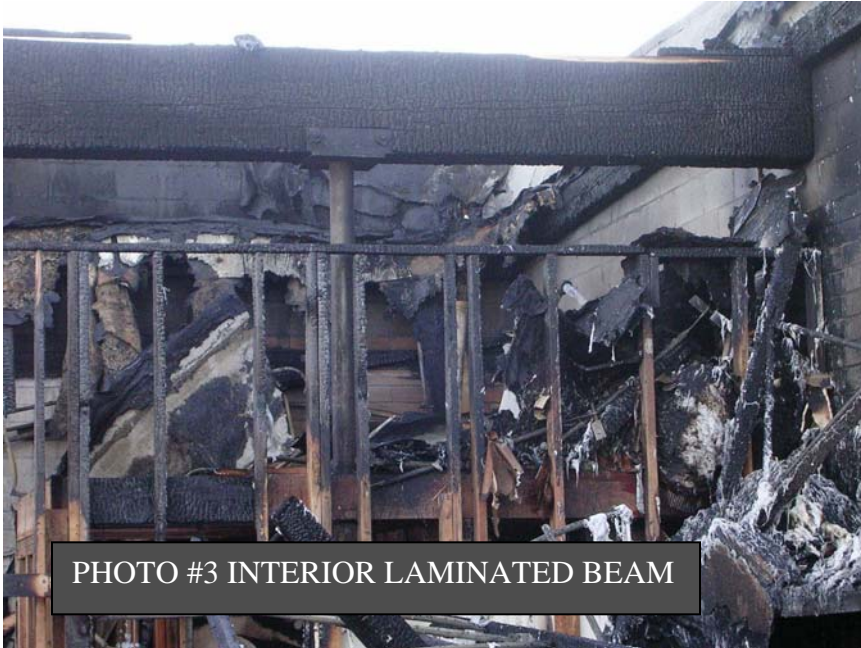
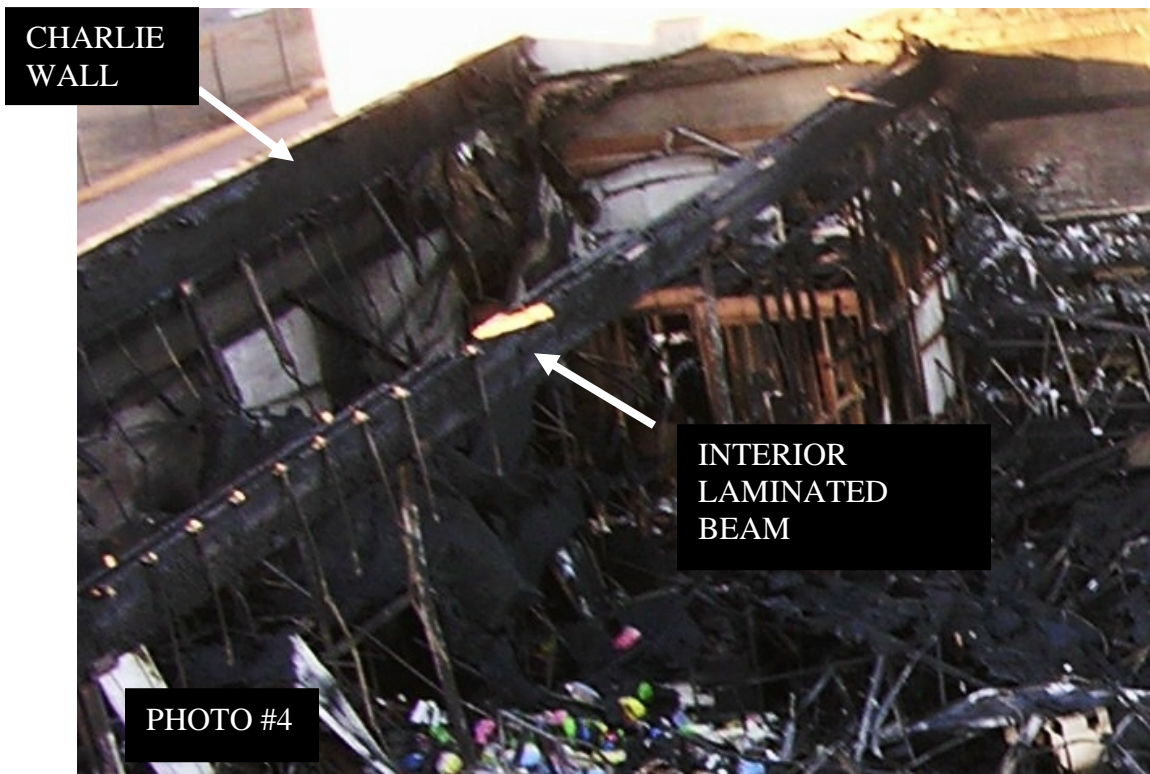
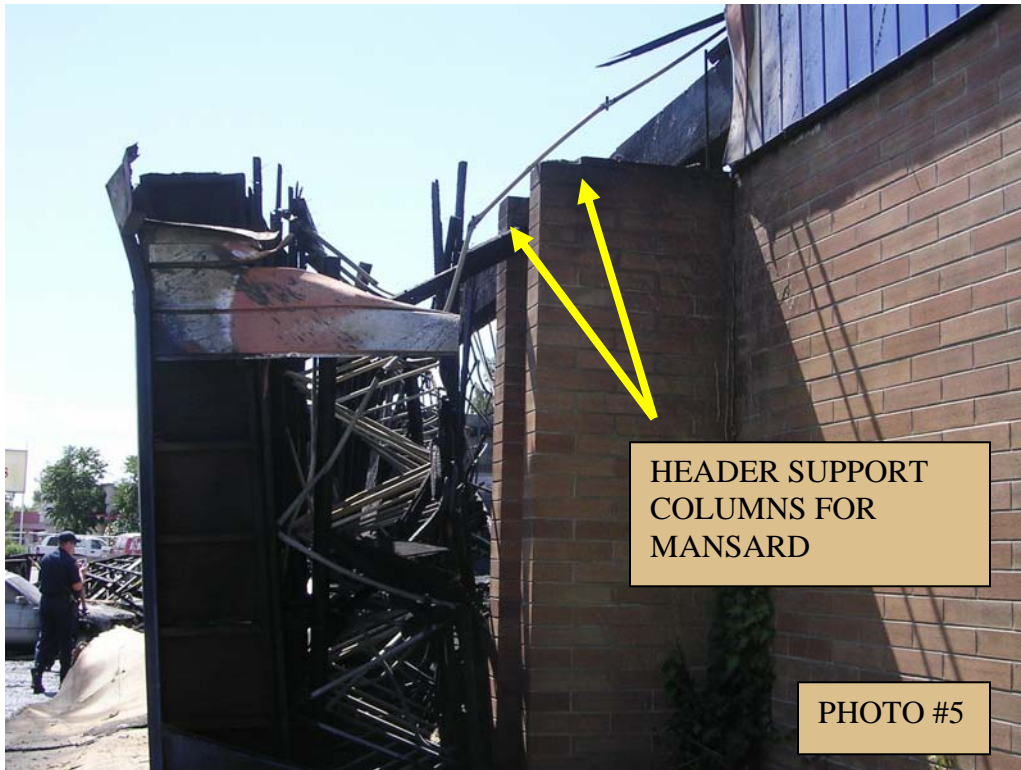
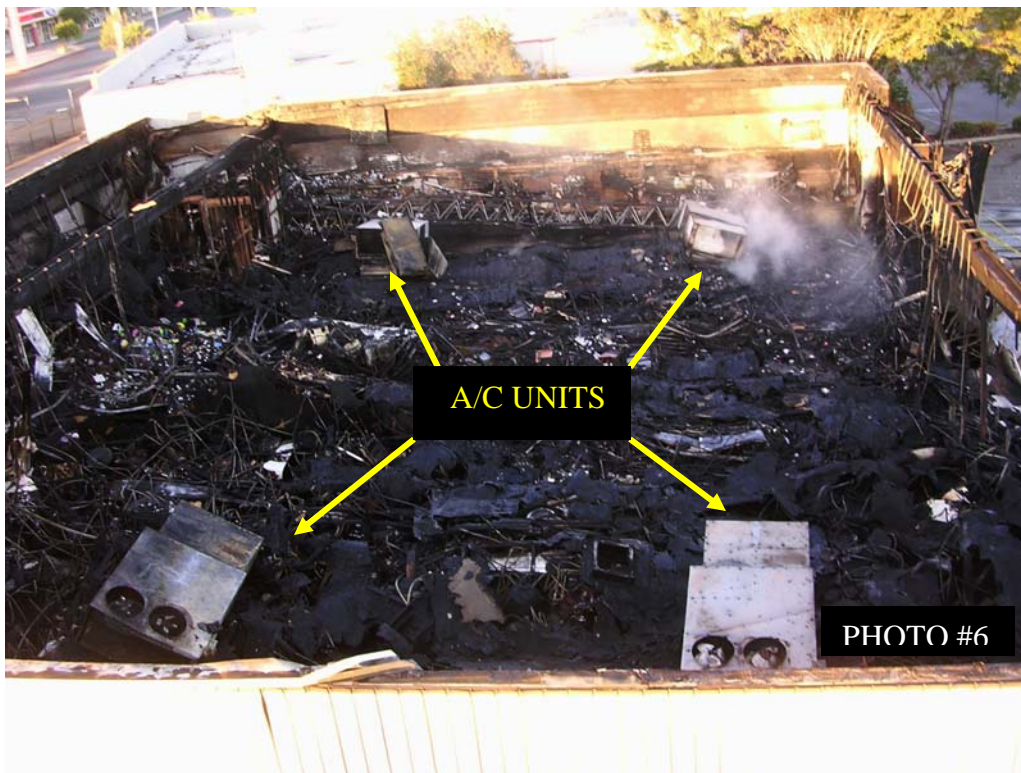
The interior of the building had a single laminated beam running from the “Bravo” side to the “Delta” side of the structure supported by 6 inch steel posts. The beam was positioned 19’ from the “Charlie” wall. (See Photo #3, #4) This area to the rear had an independent truss assembly to support the rear of the roof, while the main truss assembly ran from the inside laminated beam to the header located at the front of the store. Extending past the glass front windows was a mansard that was supported from the front header to a smaller header that was supported by two walls extending past the front of the building. (See Photo #5) Atop the roof sat four commercial A/C units with an estimated weight of 1100 lbs each. *Note; the reported weight of the A/C units was provided by Buetler Heating and Air-conditioning Sacramento. Company Engineers estimated the weight based on photographic documentation and the age of the building.* It is undetermined if these units were supported in anyway from below. (See Photo #6) The business was operating as a supplier and manufacturer of products for the cosmetic nail industry. The business was permitted to have no more than 1600 gallons of flammable liquids on site. The business owner told Arson Investigators that he had in excess of 1000 gallons of flammable liquids consisting of acetone, polish remover, liquid monomer, and 70% alcohol, on site at the time of the fire.

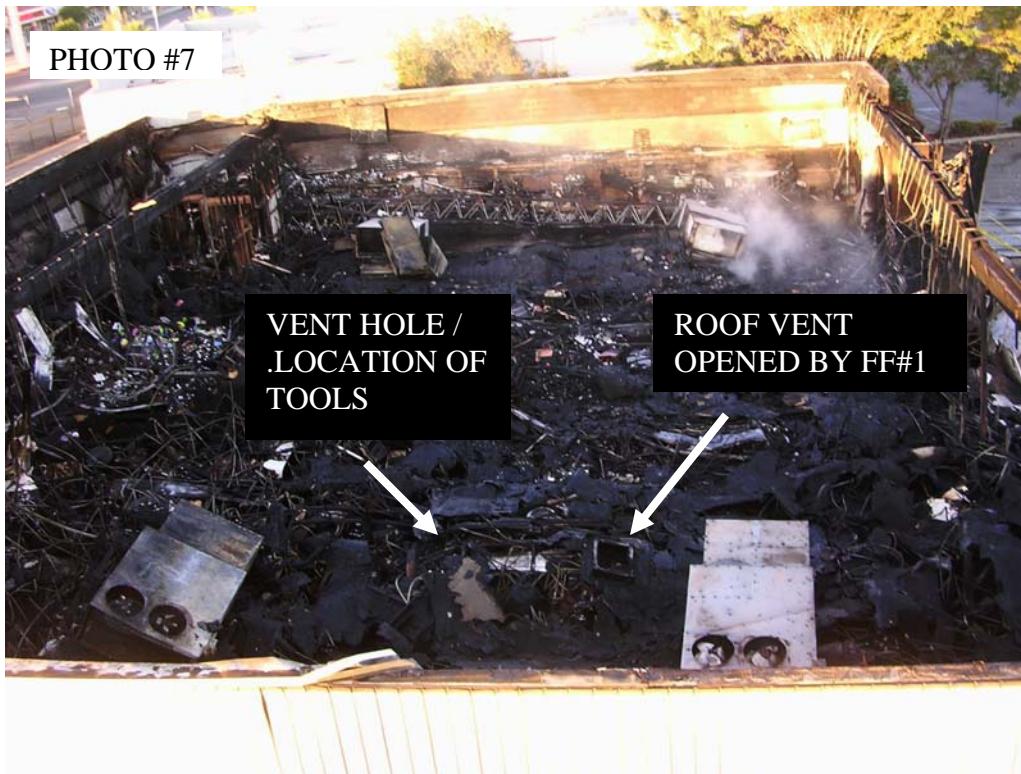
Note; the crew told investigators they felt they had identified the supporting beams and purlins and that the roof was solid. At a point near the middle of the roof, between two large A/C units, the crew made their way out on the roof towards the "Delta" side of the building. At a point approximately 12 feet out from the "Bravo" wall they made their first cut. FF#2 cut a 4'x 4' hole while FF#1 sounded the roof around him. The roof covering was pulled back, and an attempt to louver the cut was unsuccessful. They then rolled the roof material back and found little smoke coming from the hole. *Note; at the time the hole was cut, video footage from the fire scene shows large amounts of smoke coming from the location where T10 was operating.* FF#1 then pulled a vent cover off and had significant smoke from the vent. (See Photo #7)
